## GRAVESHAM BOROUGH COUNCIL

# WINDMILL HILL CONSERVATION AREA

### *Scope and Purpose of Report*

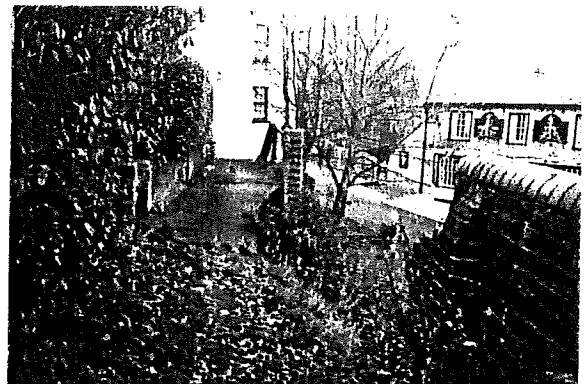
All properties make some contribution to the character of the Area, with two exceptions. Kingdom Hall on Shrubbery Road is a neutral feature because of its scale and facing materials. The path to Primrose Terrace is in poor structural condition and

*Structural and ownership problems have hindered repairs along Primrose Walk*

its restoration needs urgent consideration. Secondly, 36 and 36A-D Clarence Place are neat enough modern properties but lack any resonance with their context. The extensive garage court in front of these is also an alien feature in this part of the Area.

- Take steps to bring 12 Clarence Place from its present dilapidated state
- Rationalise street signs on Parrock Street by Christ Church Gardens
- Rationalise boundary treatments in and around Windmill Hill Gardens
- Improve Kingdom Hall car park and the forecourt to Windmill Tavern
- Rebuild the retaining wall to Primrose Terrace and restore the steps and path
- Improve boundaries to Veterans Club, to match plinth wall and railings either side of main entrance
- Improve front curtilages, particularly 34-35 and 37 Clarence Place. Article 4 directions to control further alterations
- Promote co-ordinated painting schemes for existing external rendered and painted surfaces (Article 4)

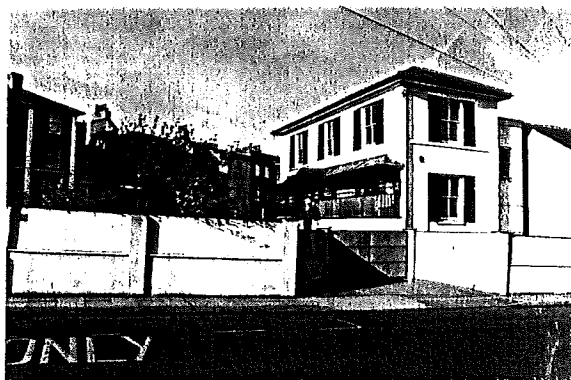
*Improvements to the boundary walls and gates would enhance this corner site*

91 Parrock Street is included on the east side as a significant building in townscape. Despite some excellent ironwork at first floor level, it has unfortunately lost its chimneys and thus its general proportions. The prominent but unadorned front wall with its solid metal gates are out of sympathy with its historic setting.

- Improve front boundary and gates, 91 Parrock Street
- Improve surfaces, William Street

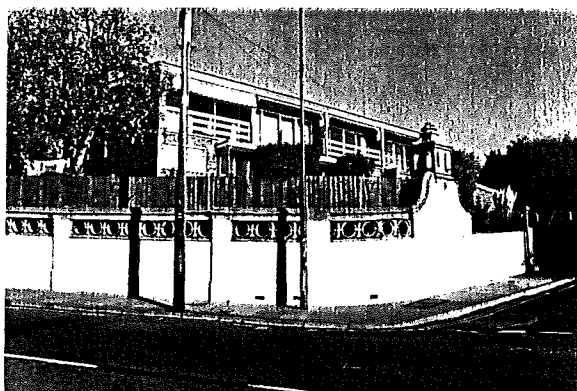
*Westhill Close looms over the remains of William Aspdin's boundary wall*

to the open aspect of this part of the Conservation Area. Post-war infill at 1-7 Leith Park Road and 1-7 Westhill Close are aggressively horizontal in their design and thus must be regarded as negative features along with the modern houses 7A-B and 9A-B Parrock Road with their open forecourts.

- Plant up and improve Tivoli Gardens frontage
- Preserve the remains of the frontage wall built by William Aspdin

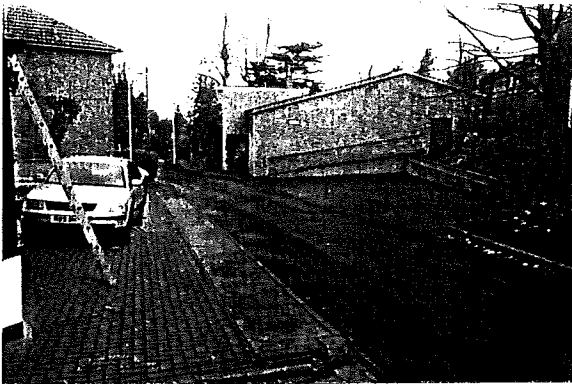
*Kingdom Hall's side elevation would be enhanced if the car park were landscaped*

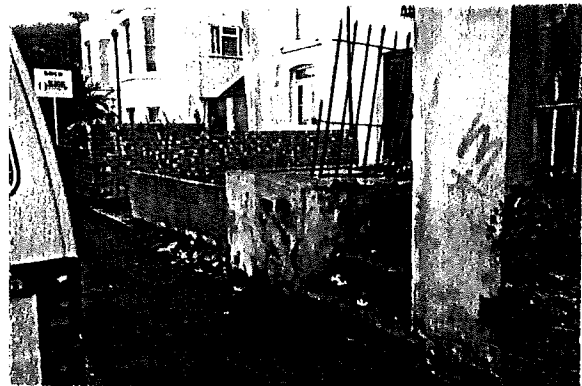
*The restoration of these front boundaries would be a significant enhancement*

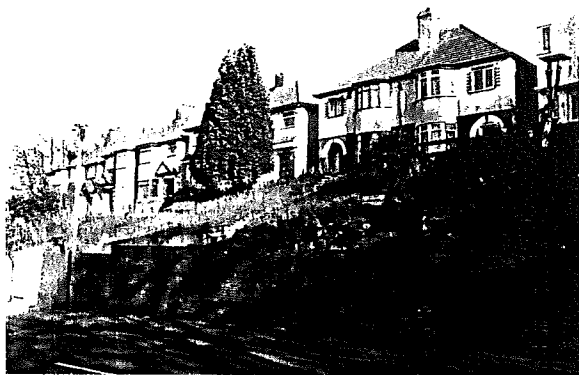
*The bank in front of Tivoli Gardens needs comprehensive treatment*
